# Security instruction table stand DV1300C2Cu + V1300C2AI

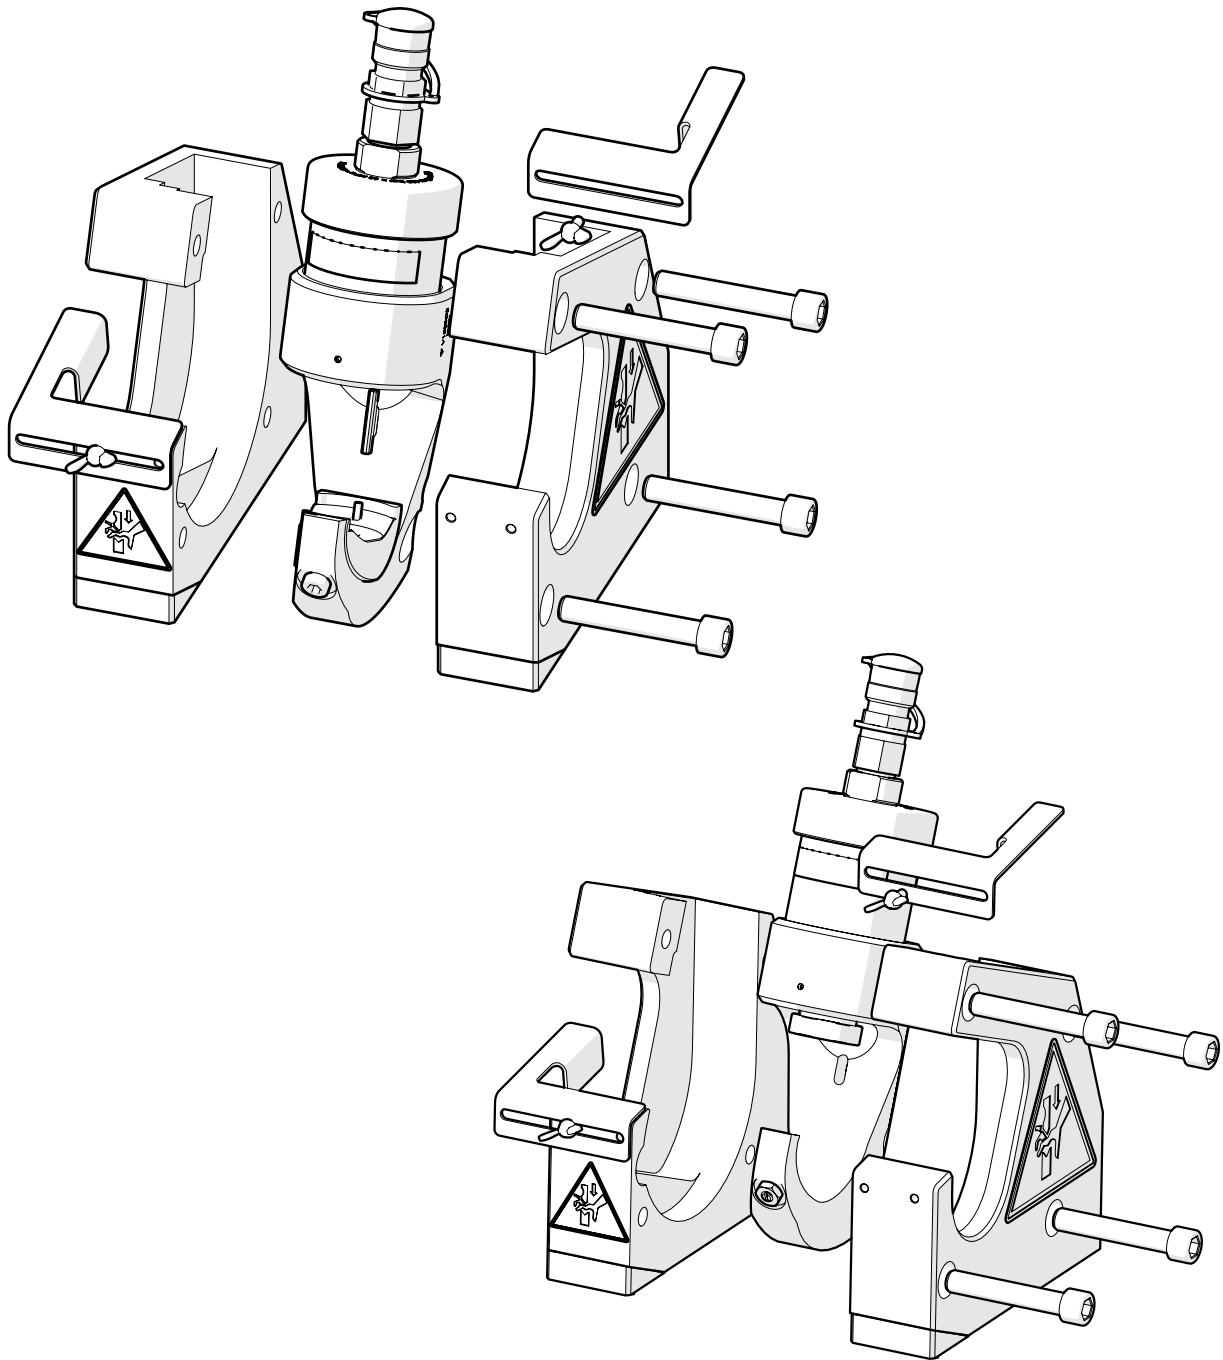
To make the security test the tablestand need to be removed. That is easily done by just loosen the screws.

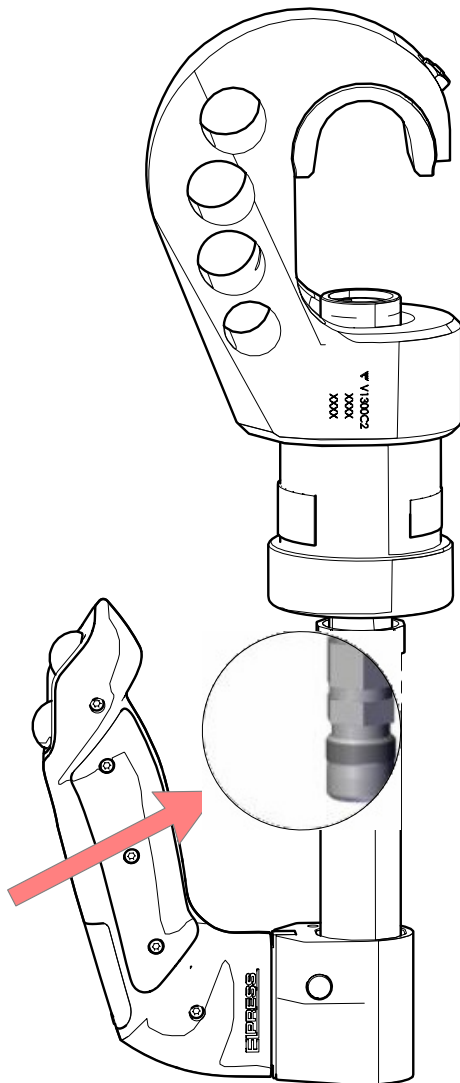
Risk for oil leakage in the quick coupling, see the area the arrow shows. It's very important that the Ergo pipe is not loosen and it has it's original position to prevent sudden oil leakage.
